<b>Manufacturing Ref:</b>	2126514838 (1) 41101		<b>Independent Ref:</b>	226846	
<b>Manufacturing Details:</b>			<b>Customer Details:</b>		
Default Manufacturer View Logistics Brenda Road Hartlepool Durham TS25 1HT Tel: 000000			Mr Nick Todd 8 Lych Way Woking Surrey GU21 4QG Tel/Mobile: 07760 333998 / 07760 333998		
<b>Instruction Details:</b>	Fitting Date: 19/12/2018 Length/Width: 26.2000/5.00 Invoice No: 2173960 Colour/Pattern: RIVERSIDE TWIST 40 AVON 5M				
<b>Date Received:</b>	26 April 2019	<b>Date Inspected:</b>	Unknown 06 May 2019 20:31	<b>Inspected By:</b>	Gordon Watkins

### Flooring Details

## MANUFACTURING INSPECTION REPORT

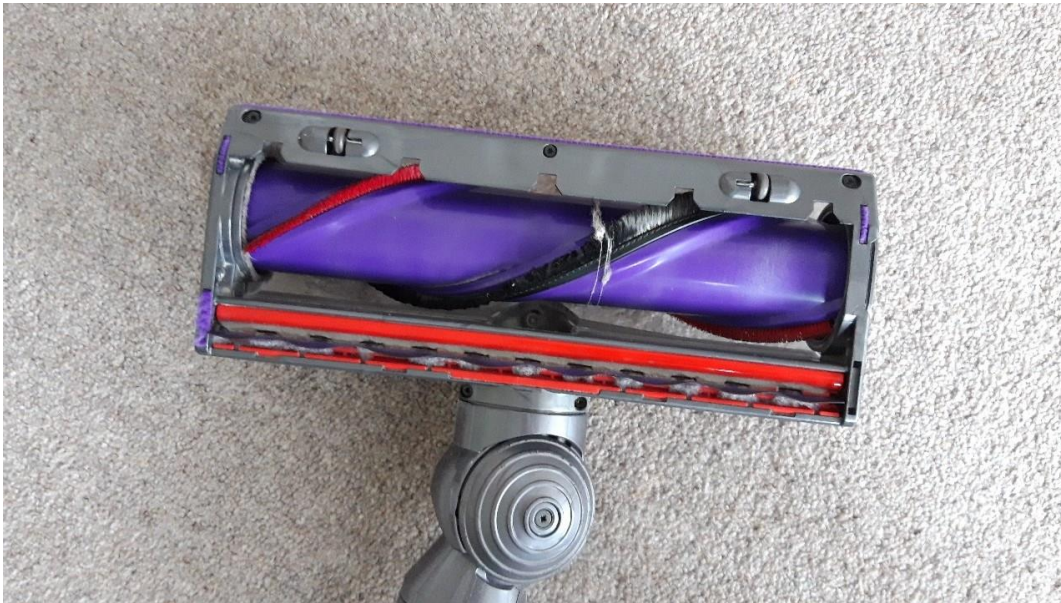
**Image Name:** ce461e96-908f-4c0a-894a-3ff1f08297a5.jpg

We inspected the flooring in the presence of:	Mr & Mrs Todd
Who are complaining of:	pressure banding
They noticed the complaint when:	on day of installation
Upon closer inspection we discovered:	<p>We were initially instructed to carry out remedial steaming of the carpet to remove what was reported as pile reversal. However after viewing the hallway carpet we quickly identified this as pressure banding. This is not present in any of the other fitted areas so would assume that this has occurred to this section of carpet whilst stored at the retailer. It is our understanding that the hallway carpet was fitted at a later date than the rest of the carpets and as the pressure banding is not present on any of the other sections of carpet we would assume that this occurred to this section of carpet whilst being stored, waiting to be fitted.</p> <p>We were informed that the carpet was fitted in December and there has been no improvement in the carpets appearance despite being maintained on a daily basis with a vacuum fitted with a rotating beater bar brush.</p> <p>We felt that steaming the carpet will not rectify this issue so carried out a full inspection.</p> <p>Given the length of time since the initial carpets were fitted it is unlikely that a replacement section of hallway carpet would be able to be attained from the same batch . We were informed by the consumer Mr Todd that the retailer was initially going to replace this section of carpet but there was a vast difference in colour which was not acceptable. Because pressure banding will occur after production of the carpet at the manufacturers we would not consider this to be a manufacturing fault and on this occasion are unable to rectify the complaint.</p>
