P27382 Development & Property Services Ltd

81 Becklow Road W12 9HH

Thursday, 17 November 2016

Identified 4 Issues

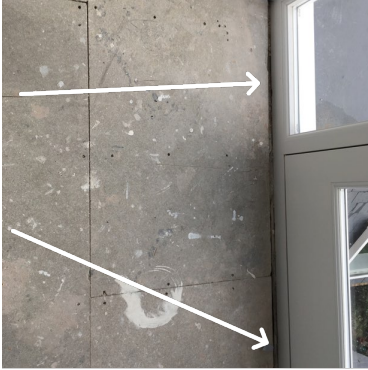
Top Floor Loft Bedroom

There is a 40mm x 1370mm gap that will require filling in prior to carpet installation

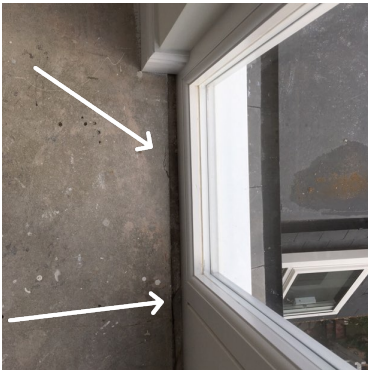
Gap In Chipboard Top Floor Loft Bedroom

40mm x 1370mm gap

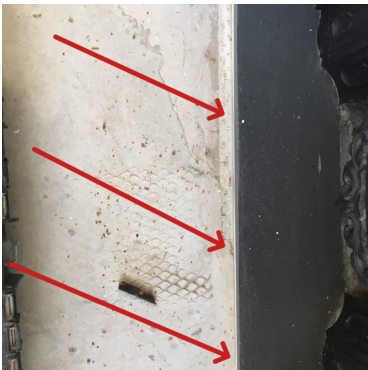
First Floor Front Bedroom

Single naplock doorbar will require removing as it has currently been screened in with latex? Also in the same room parts of the floor have been latex screeded and the screed has blown! This will need to be removed by tradesman on site before carpet installation

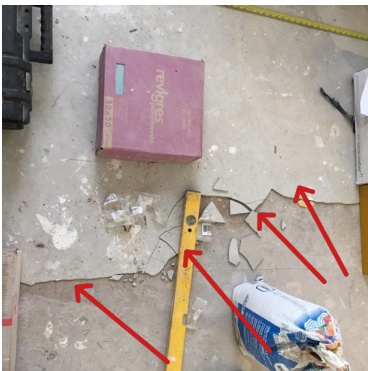
First Floor Front Bedroom

Screed blown! Parts of the existing chipboard floor is screeded and the screed has blown. The faulty screed will need to be removed and cleared prior to carpet installation
