PROJECT 15/02/2019, 10:12

Prepared For S30476 Watts

5 Issues Identified

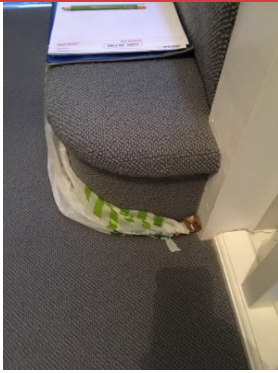
TOP BULLNOSE

SLIGHT BULGE ON LEFT HAND SIDE OF LANDING RISER

The customer asked why this has happened to which we explained that there is no gripper in the corner to compensate for the turn in the carpet resulting in a more cushioned fell that will not come undone unless it is pulled.

Kevin to look at right hand side of step and see if he can improve finish.

We advised the customer that Kevin will see if there is anything that can be done

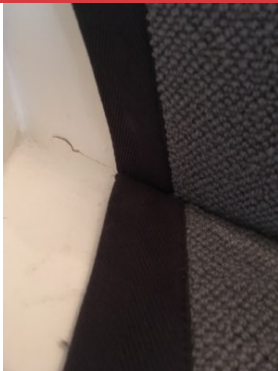
FRAYING TAPE ON WINDER 3

Fitter to pull step off of gripper, re-fit carpet and attend to the end of the tape that is currently exposed.

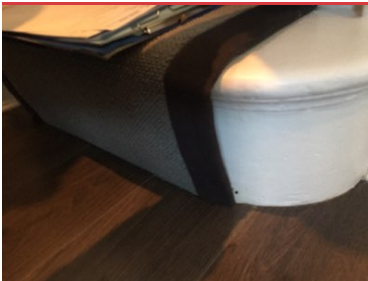
REMOVE 2X NAILS LEFT IN STAIRS FROM THE PREVIOUS INSTALLATION

Remove the old nails that are left exposed to the tread on winder 2 (right hand side) and the bottom bullnose riser (right hand side). These nails are not required to fit the new carpet and can not be reused so our fitters had no reason to remove them but we have now agreed at the customers request to remove these. This will then leave a small hole where the nails were that will need to be made good by the customer afterwards.

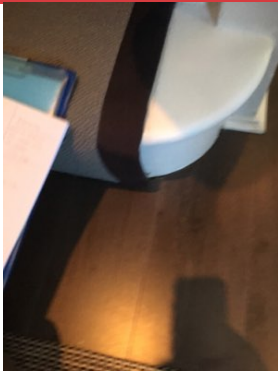
OLD PAINT VISIBLE

The customer pointed out that the old paint is visible and that the decorator had painted to the same width as the existing runner. This is not ideal as with the new runner which is the same width as the previous runner (50cm) now sitting on the new underlay there is now an exposed gap due to the thickness of the underlay that may not have been visible with the old carpet as the sides would have flattened down concealing this gap.

It was also mentioned by the customer that the runner must have not been laid straight but we demonstrated that the gap on each side of the runner are equal proving that the runner has been fitted correctly.
