S33255 – Flannagan

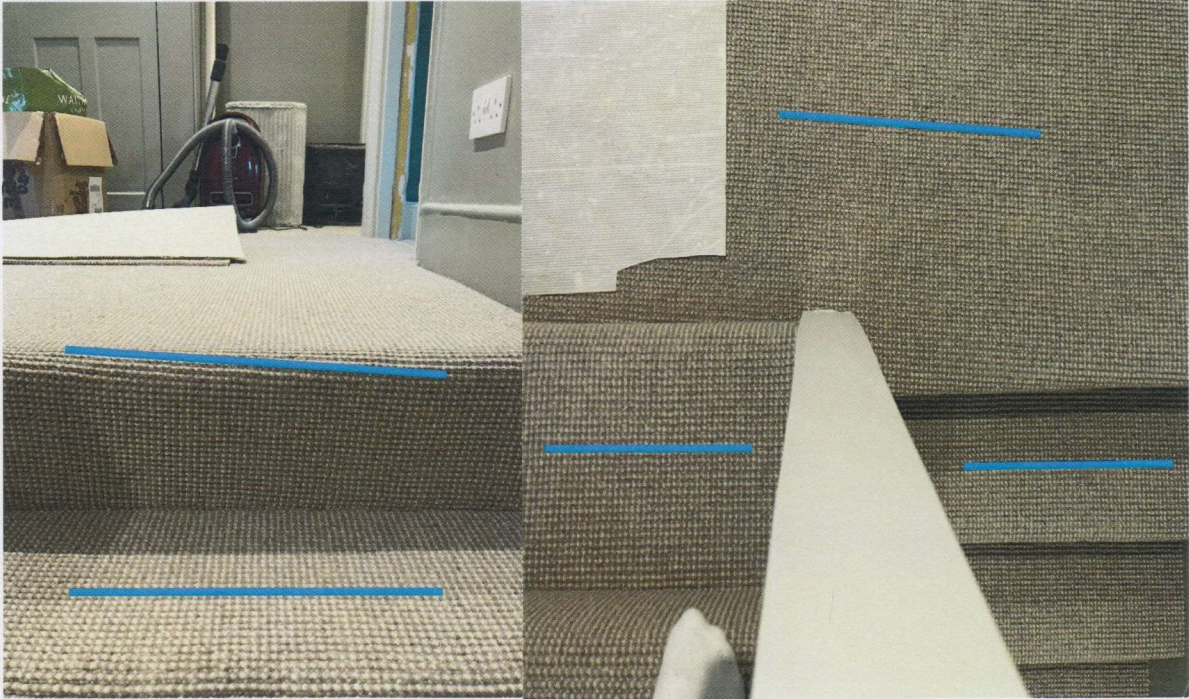
1).

Main Landing is laid wonky, requires replacing

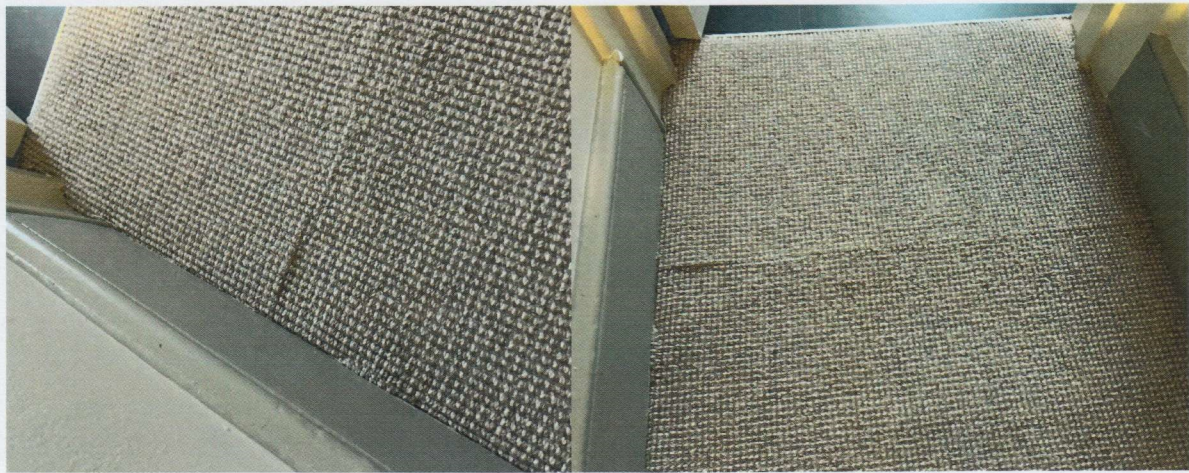
2).

Seam on Main Landing to be improved. When the Main Landing is replaced, please re-do the main landing seam as far away from the bathroom doorway as possible

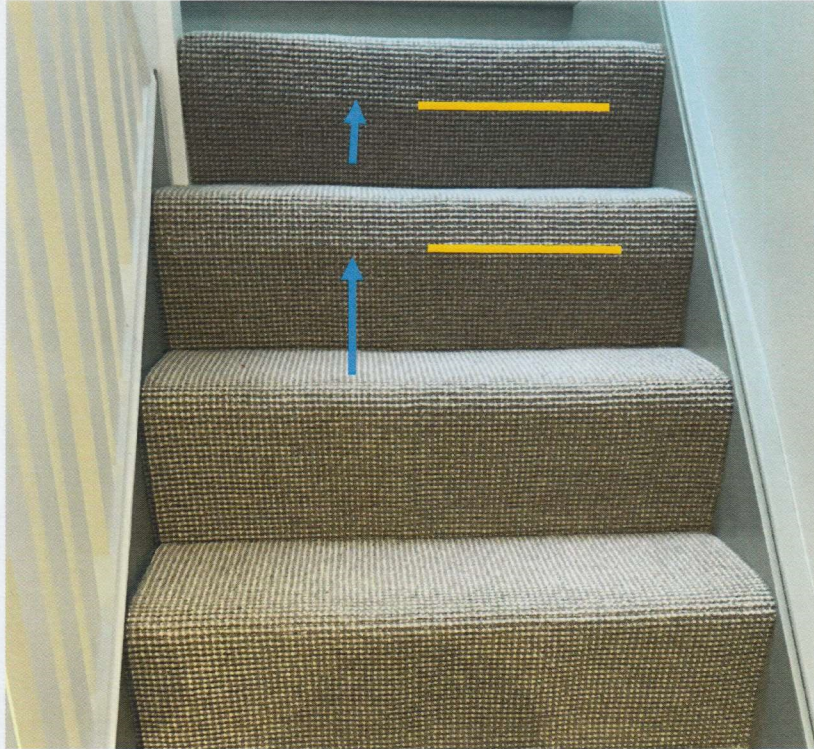
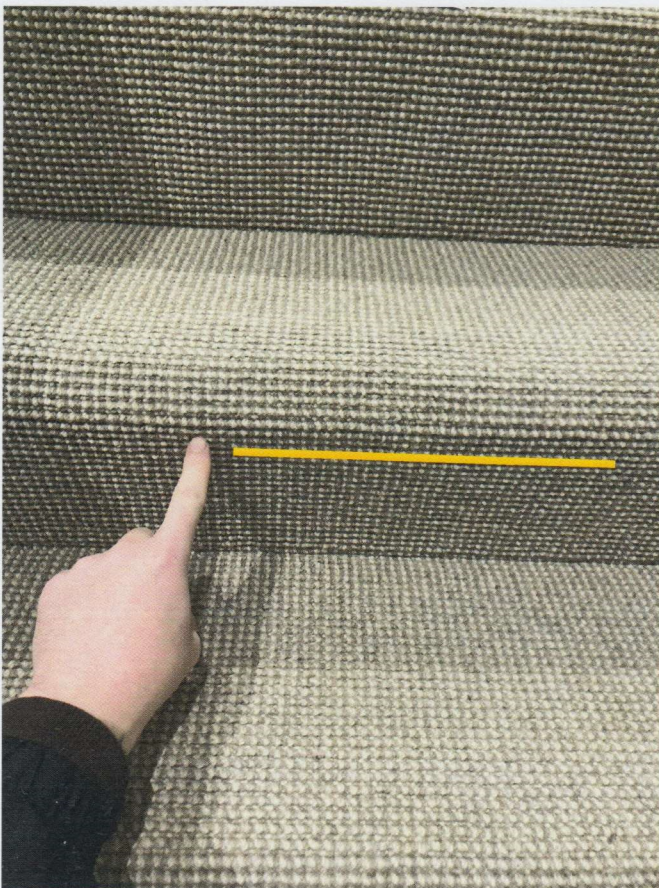
3).

Top two stairs on this flight and a few others require lifting up and having the overhanging underlay trimmed. On 90% of the stairs it seems that the underlay finishes on edge of nosing, causes no bulging and looks good, whereas the steps where the underlay folds over and not secured in place is trying to take its original shape and makes the carpet bulge. I have marked the bulge lines with yellow.
