SCHREITER

Works done 18-01-2017

Identified 8 Issues

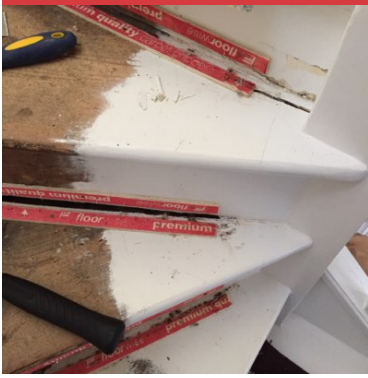
ISSUE 1

Assigned To Winders Before Filling.

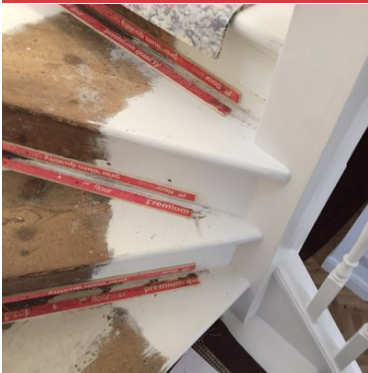
ISSUE 2

Assigned To Winders After Filling

We had to secure a piece of wood to the back of the step in order to fill the deep crack where the original piece of wood at the back of the step is missing.

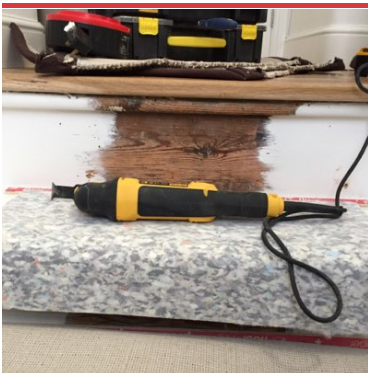
ISSUE 3

Assigned To Main Stair Nosing Prior To Removal

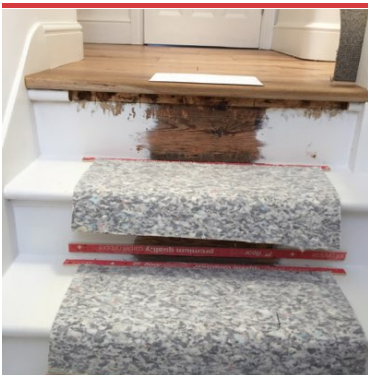
ISSUE 4

Assigned To Main Stairs Nosing After Removal

Cut away the existing wood nosing so that the carpet can fit flush against the riser meeting the underside of the wooden nosing fitted to landing. The same work was carried out to the existing wood nosing on the loft flight of stairs.

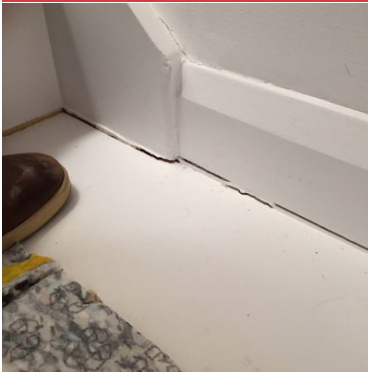
ISSUE 5

Assigned To Movement To 1/4 Landing On Loft Flight

This appears to have developed since we fitted the carpet. As we had the filler we have applied it to the crack and will also paint whilst we are there attending to other areas.

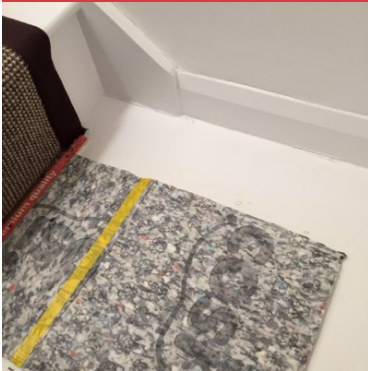
ISSUE 6

Assigned To 1/4 Landing On Loft Flight After Filler

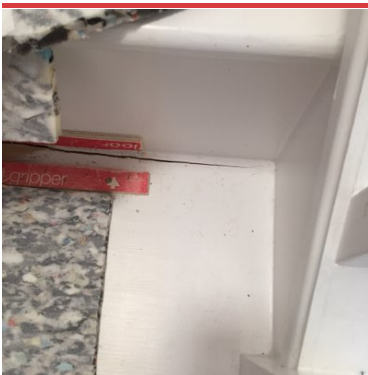
ISSUE 7

Assigned To Splits In Wood To Back Of Stairs Prior To Filling And Painting

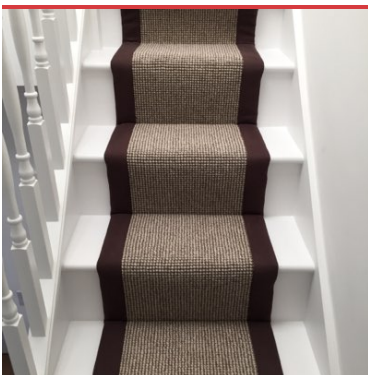
ISSUE 8

Assigned To After Splits To Stairs Have Been Filled

Once the filler has dried we will paint over the filler before and during the installation if required.
