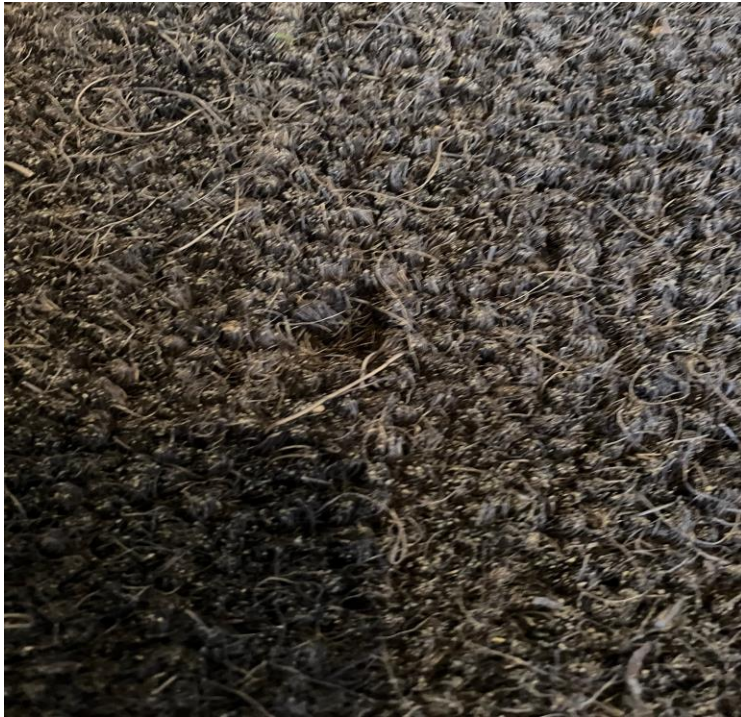
Tufting issue in coir matting – requires replacement

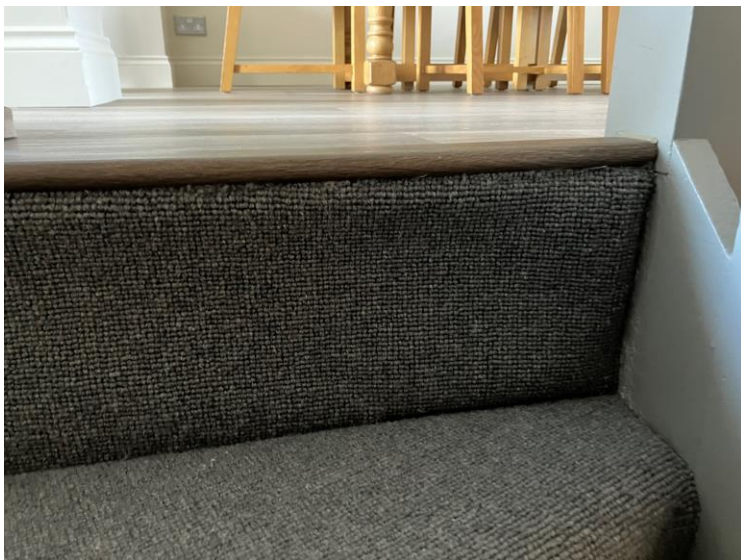
Bulge in carpet where carpet is sitting over original landing nosing. A more appropriate LVT nosing which overhangs the original landing step means that this junction is hidden rather than what is currently installed which left installer no option but to cover the original landing nosing with the carpet. The current carpet can be tidied up in small areas to improve, but the above bulge at the top is unavoidable.

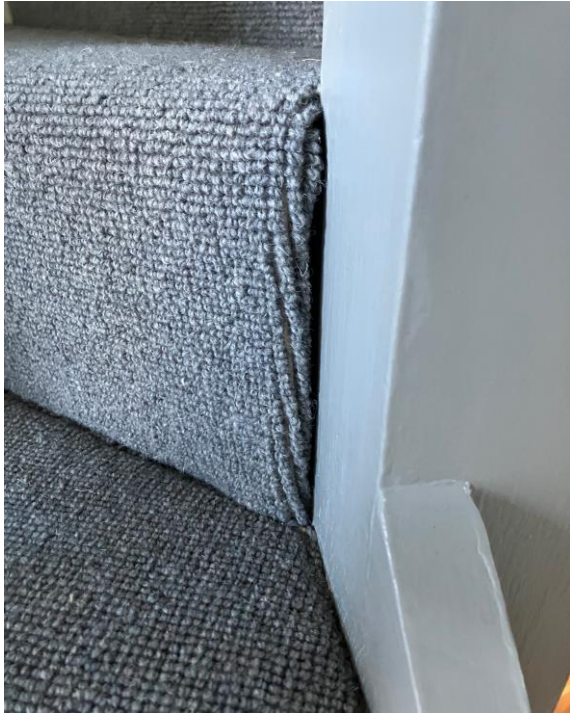
Carpet folded as expected, but do to the angle of the step itself causing effect to be exaggerated. This can be tweaked to disguise as best as possible, or potentially tacked in with a nail to compress the fold and close the grinning loops. This repeats itself on a few more 'winder' steps

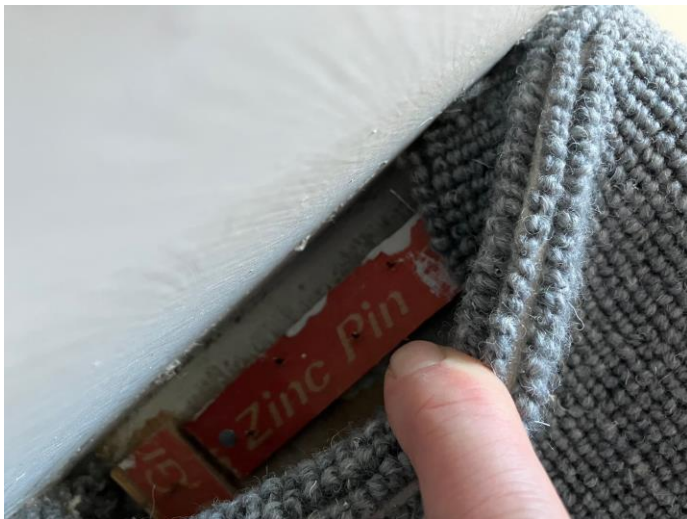
Carpet at top landing bulging on existing gripper due to too much excess carpet being folded behind carpet. Carpet to be pulled back, excess trimmed and carpet re-installed.

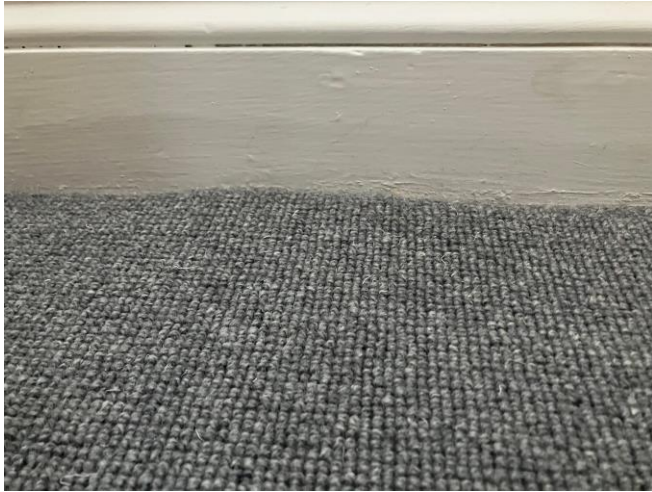
Existing gripper rod has lifted from the subfloor and is cause bulge. Carpet to be pulled back, gripper to be re-secured and carpet to be re-installed

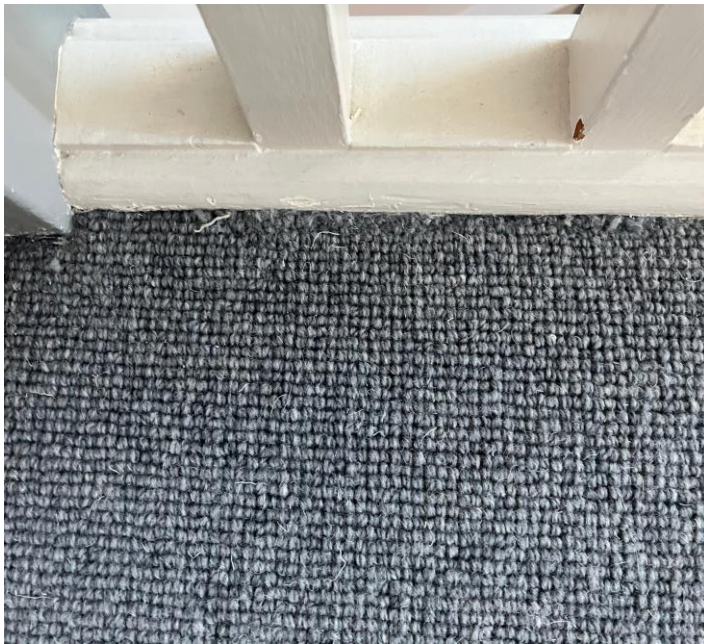
Carpet on Top Landing at bannister base needs tidying up

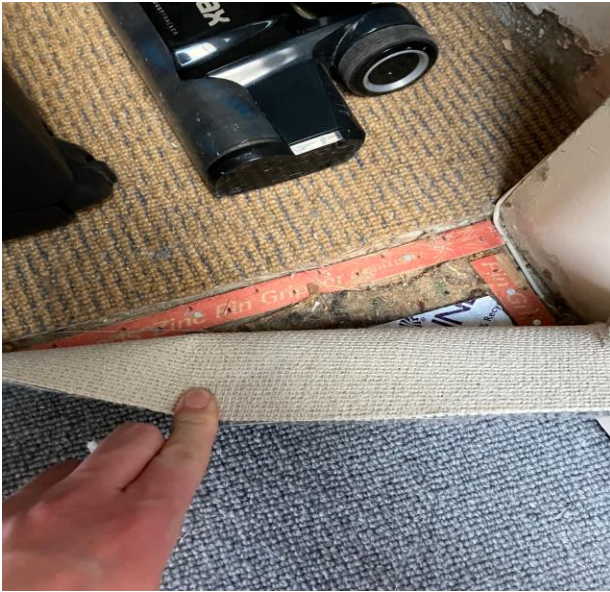
Carpet at top cupboard landing to be trimmed back and installed into gripper rods neatly

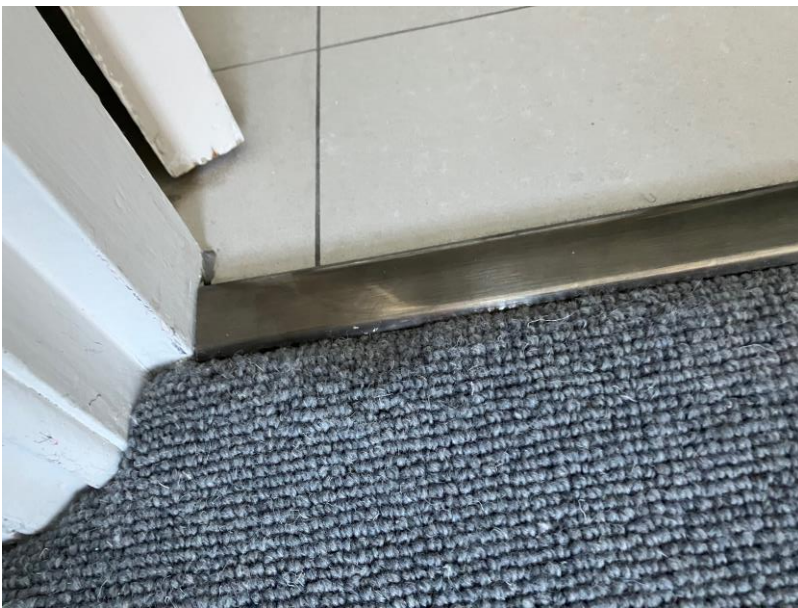
Bulge at en-suite as door bar needs a further securing nail and carpet re-installing.
