Colin Symonds
Mr Carpet Ltd

P27671 MCKERNAN

Tuesday, 13 June 2017

3 Issues Identified

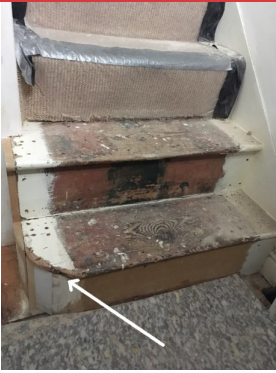
BULLNOSE STEP

The bottom bullnose step that finishes to the hallway will require some remedial work by the appropriate tradesman before new carpet can be installed on to it.

As discussed on site the tread of this step should ideally be replaced to resemble the appearance of your bullnose step on the new top flight of stairs to your loft bedroom. We would then be able to fit the tread (cap) of this step and would recommend that the Riser of this step could be painted as this would provide the most aesthetically pleasing finish at this juncture?

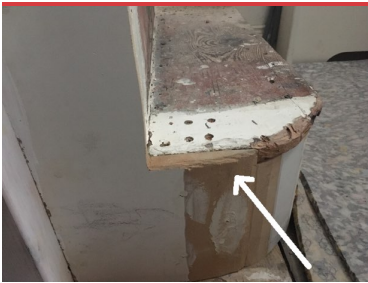
BULL NOSE STEP

There is currently no lip on this tread to finish the carpet underneath so needs work by the appropriate tradesman before carpet can be installed to it!
