P28861 Duncan

9 Dyers Lane SW15 6JR

Prepared For Alex & Jemma Duncan

3 Issues Identified

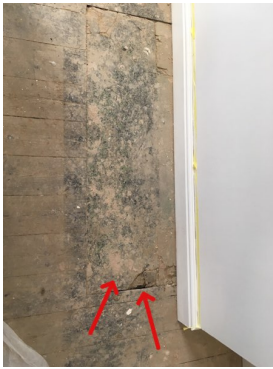
Front Bedroom Hearth

The concrete hearth in the front bedroom is damaged/broken and will therefore require repair by the appropriate tradesman prior to carpet installation.

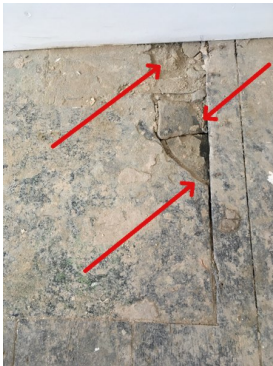
Front Bedroom Hearth

Closer View of damage

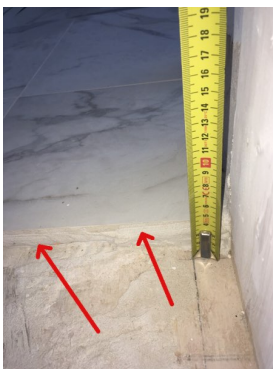
Top Floor Bathroom

The tiles in the top floor en suite bathroom / wet room will be significantly higher than the finish of carpet and underlay (approx 20mm) we would therefore suggest that it may prove more aesthetically pleasing if a wooden threshold was installed at this juncture by your builder/carpenter as the products that we have available for carpet fitters to install would not provide a suitable finish. The threshold should ideally butt up against the height of the tiles on the bathroom side and then drop to the height of approx 20mm on the bedroom side so a neat finish can be achieved by butting the carpet up against the wooden threshold
