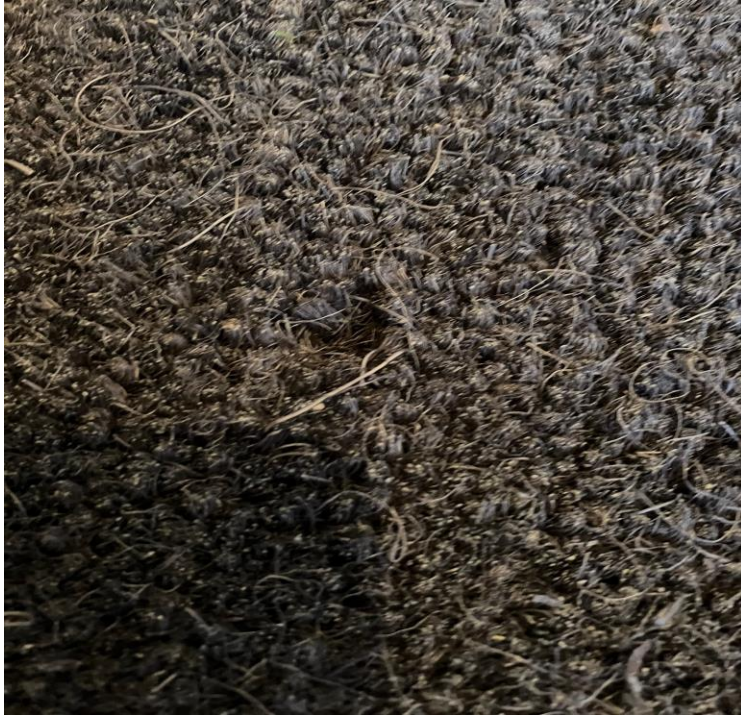
Tufting issue in coir matting – requires replacement

JAMIE PLEASE REPLACE

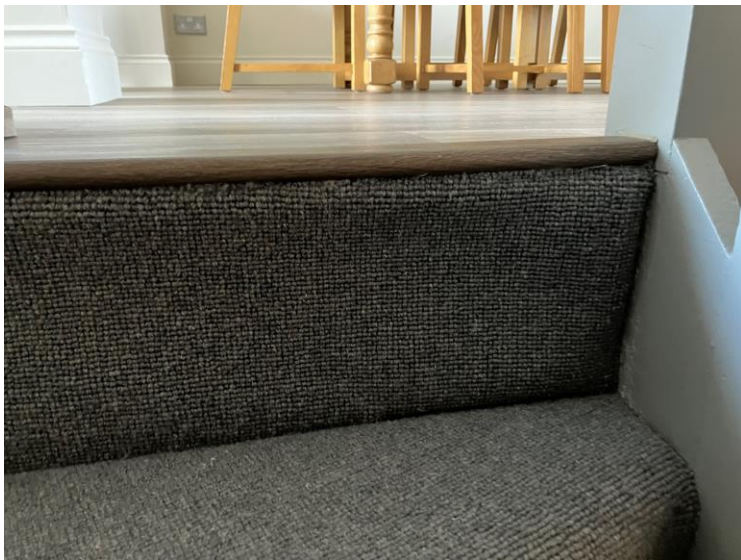
Bulge in carpet where carpet is sitting over original landing nosing. A more appropriate LVT nosing which overhangs the original landing step means that this junction is hidden rather than what is currently installed which left installer no option but to cover the original landing nosing with the carpet. The current carpet can be tidied up in small areas to improve, but the above bulge at the top is unavoidable.

JAMIE I HAVE ADVISED THERES NOT A LOT THAT CAN BE DONE HERE WITHOUT THE CORRECT NOSING INSTALLED

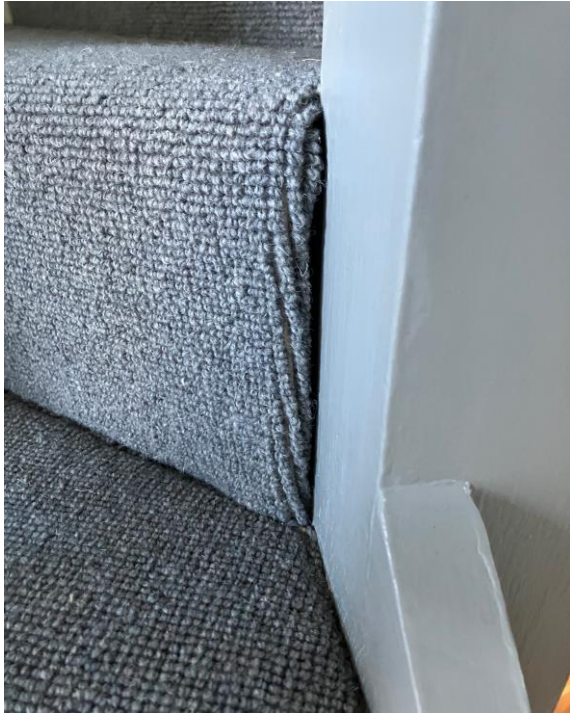
Carpet folded as expected, but due to the angle of the step itself causing effect to be exaggerated. This can be tweaked to disguise as best as possible, or potentially tacked in with a nail to compress the fold and close the grinning loops. This repeats itself on a few more 'winder' steps

JAMIE PLEASE SEE IF THIS CAN BE IMPROVED IN ANY WAY, BUT I HAVE EXPLAINED ITS DUE DOWN TO FOLDS AND ANGLES

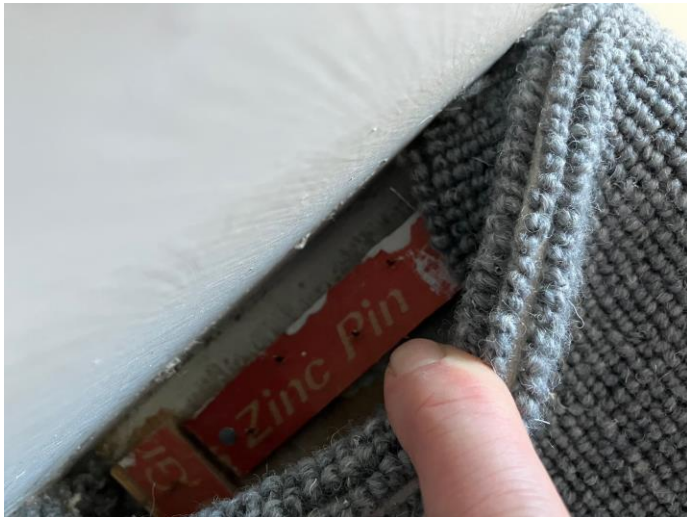
Carpet at top landing bulging on existing gripper due to too much excess carpet being folded behind carpet. Carpet to be pulled back, excess trimmed and carpet re-installed.

JAMIE PLEASE PULL BACK CARPET AND REMOVE EXCESSIVE FOLDED CARPET TO REMOVE BULGE ON TOP LANDING.

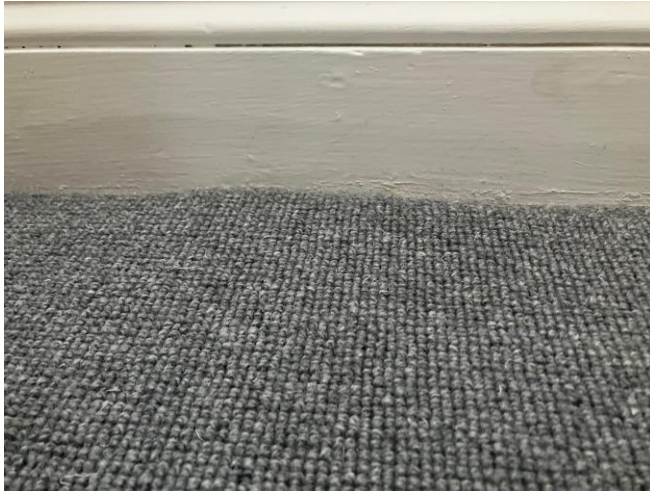
Existing gripper rod has lifted from the subfloor and is cause bulge. Carpet to be pulled back, gripper to be re-secured and carpet to be re-installed.

JAMIE CAN YOU PULL BACK MATERIALS AND RE-SECURE CARPET

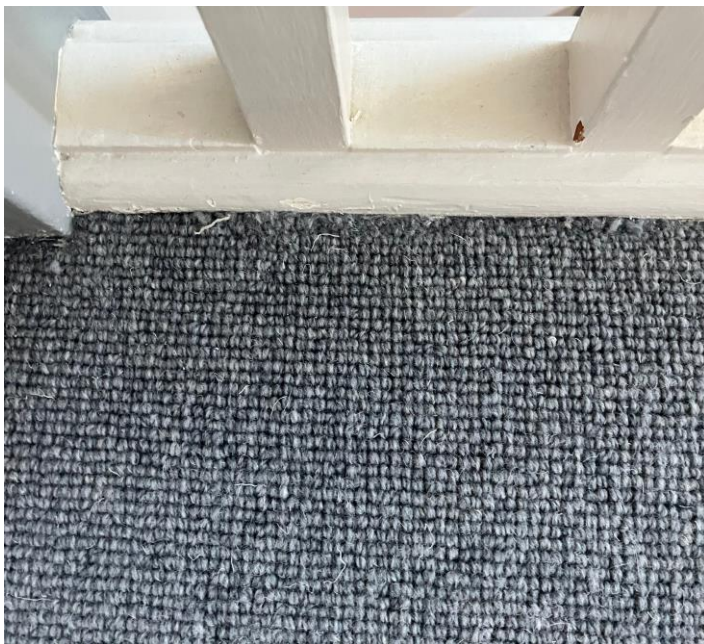
Carpet on Top Landing at bannister base needs tidying up

JAMIE CAN YOU PULL BACK, NEATEN AND RE-INSTALL

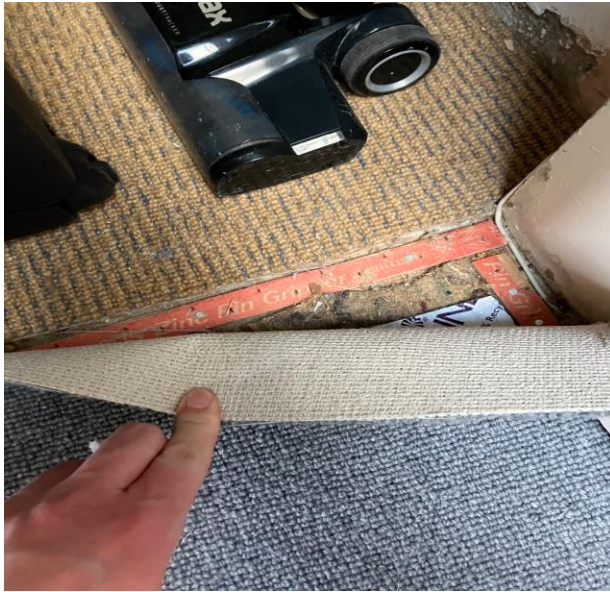
Carpet at top cupboard landing to be trimmed back and installed into gripper rods neatly

JAMIE CAN YOU PLEASE TRIM CARPET BACK AND INSTALL ONTO GRIPPER RPOPERLY AGAINST EXISTING CARPET

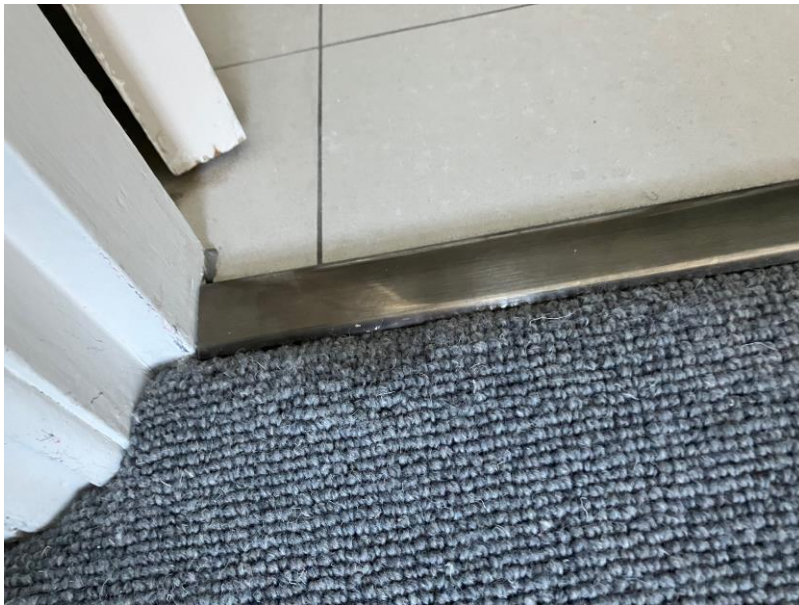
Bulge at en-suite as door bar needs a further securing nail and carpet re-installing.

JAMIE CAN YOU PULL CARPET BACK AT EN-SUITE, PIN DOWN DOOR BAR AND SORT OUT CARPET BULGE
