P27327 Poll

26 Bracken Gardens SW13 9HW

Tuesday, 18 October 2016

Identified 6 Issues

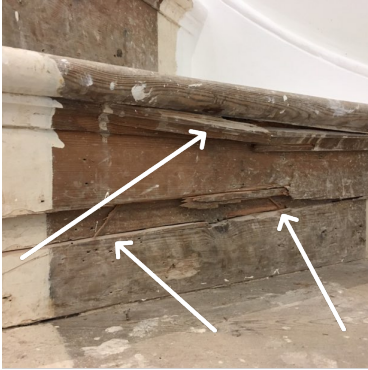
Broken Stair (Top Flight)

The riser and also the scotia beading on this winder Stair will require repair by the appropriate tradesman prior to carpet installation

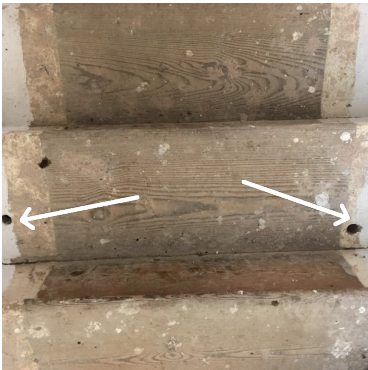
Holes In Stair Treads

Ideally these holes should be filled or plugged prior to carpet installation to avoid draught marks showing through the carpet in due course

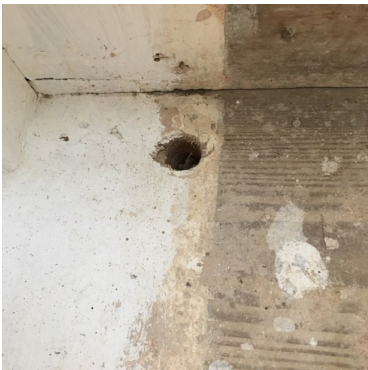
Holes In Stair Treads

Ideally these holes should be filled or plugged prior to carpet installation to avoid draught marks showing through the carpet in due course

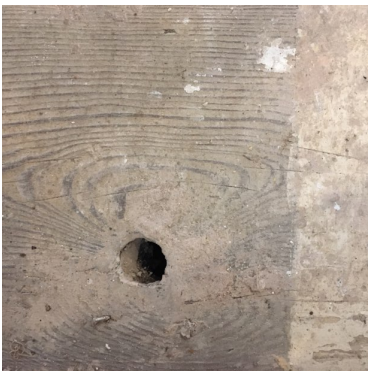
Holes In Stair Treads

Ideally these holes should be filled or plugged prior to carpet installation to avoid draught marks showing through the carpet in due course

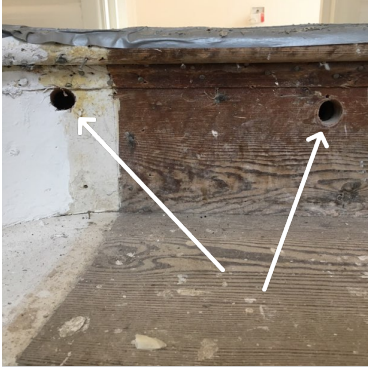
Holes In Stair Riser

Ideally these holes should be filled or plugged prior to carpet installation to avoid draught marks showing through the carpet in due course

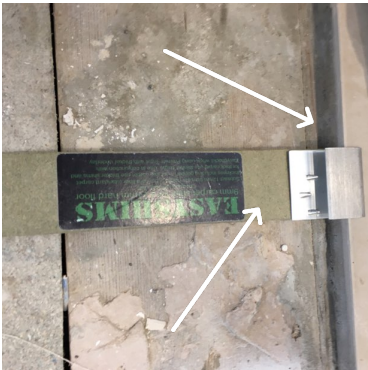
Easy Shim Ramp

To facilitate a superior finish from carpet to tiled floors we have specified to install 12mm easy shim Ramps at two bathroom doorways as this will raise the height of the carpet to the tiled level at these junctures
