Colin Symonds
Mr Carpet Ltd

P28156 FAWTHROP

25 Furmage Street SW18 4DF

2 Issues Identified

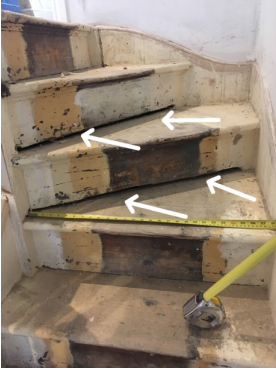
BROKEN WINDER STAIRS

Risers need repair by appropriate tradesman prior to installation of stair runner

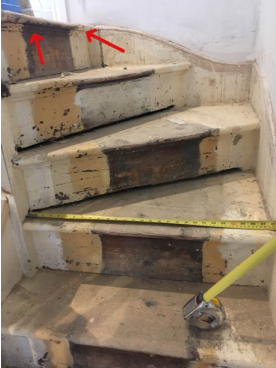
SCOTIA BEADING REMOVAL

The scotia beading would need to be removed and the gap filled and decorated accordingly to facilitate installation of a stair runner
