P27108 - 19 Welbeck Way (Mews House)

Survey Report

Thursday, 9 June 2016

Prepared For Howard De Walden Estates

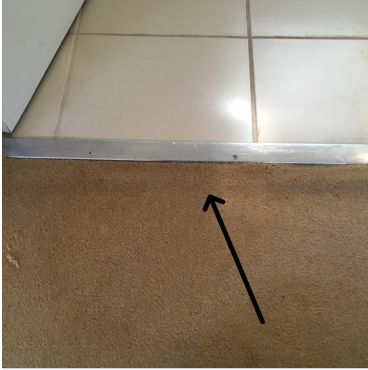
Top Floor Bathroom Ensuite Doorway

There is a ramp in the floor under the carpet at this junction. I would recommend the installation of an Easyshim ramp under the carpet to solve this problem. Additional cost £30 (See photo below)

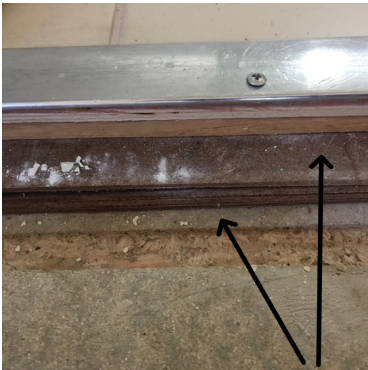
Top Floor Bathroom Ensuite Doorway

Difference in height visible through the existing carpet

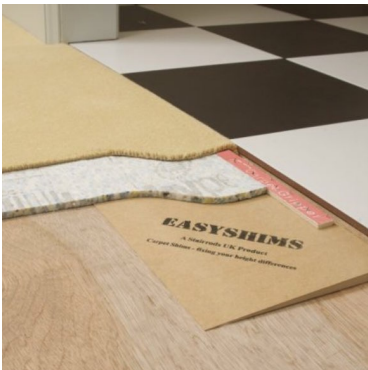
Example of Easyshim Ramp

Example of Easyshim ramp

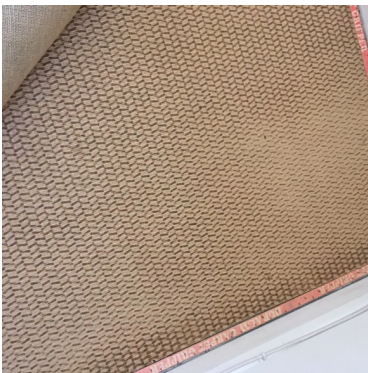
Existing Underlay

The existing underlay is very old and has started to dry out. I would strongly recommend renewing the underlay on this occasion

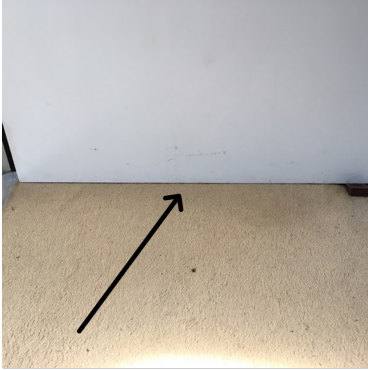
Door Clearance

The 3 bedroom doors are rubbing on the existing carpets & may require adjustment post installation. Our fitters do not offer this service so you will need to instruct your maintenance Dept if required?

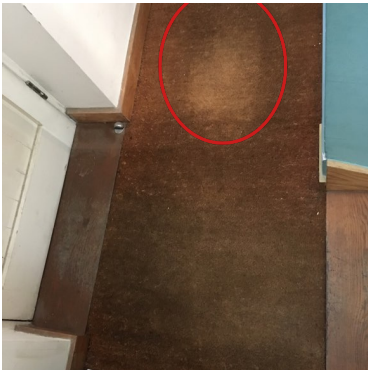
Entrance Doormatting

The existing Coir matting is quite worn so I have provided a separate quote to replace it should you wish to do so?
