P27144 - HDWE

78 Marylebone Lane (Flat 3)

Monday, 11 July 2016

Prepared For Howard De Walden estates

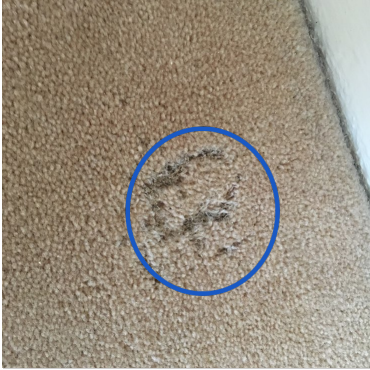
Moth Damage

Evidence of moth damage in the existing bedroom carpet

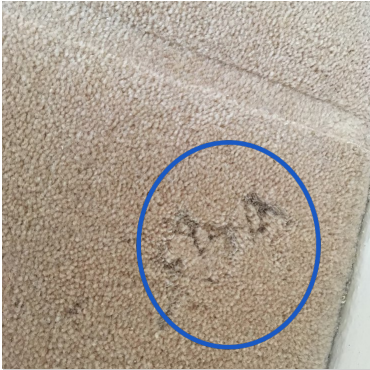
Moth Damage

Evidence of moth damage in the existing bedroom carpet

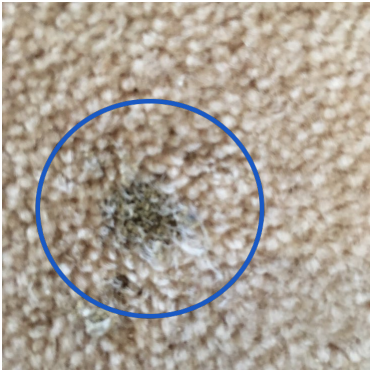
Moth Evidence

There is evidence of Moth eggs laid in existing carpet. We would therefore recommend having the areas treated for a moth infestation prior to laying the new carpets

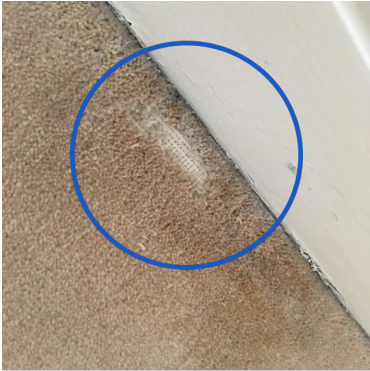
Moth Damage

Evidence of moth damage in the existing bedroom carpet

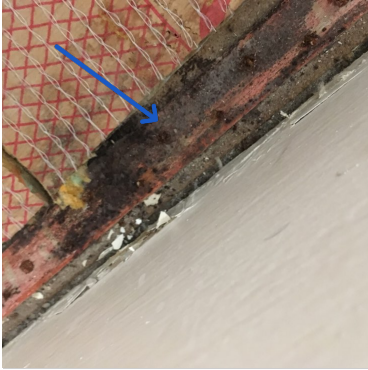
Damaged Gripper

Some of the existing gripperods will need to be replaced

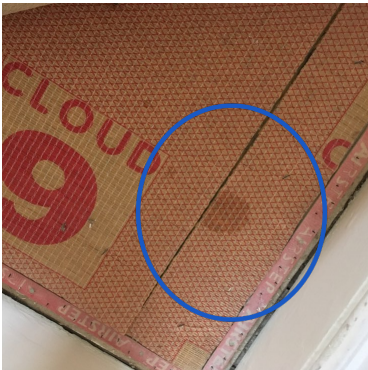
Existing Underlay

The existing underlay is stained in places & could contain moth eggs, therefore we would recommend renewing the underlay at this time to limit the chance of future contamination.

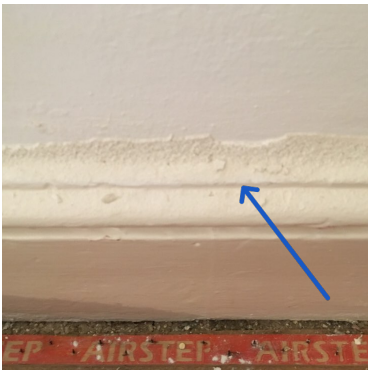
Paint Dust

There appears to be a considerable amount of paint dust on top of the skirting boards in the living room which may transfer onto the new carpet if not removed beforehand

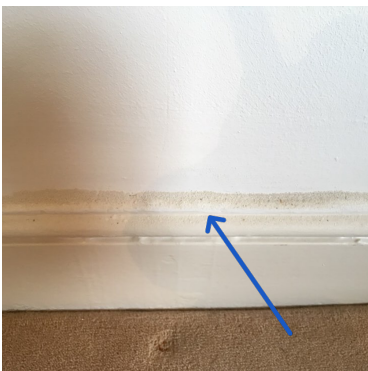
Paint Dust

There appears to be a considerable amount of paint dust on top of the skirting boards in the living room which may transfer onto the new carpet if not removed beforehand
