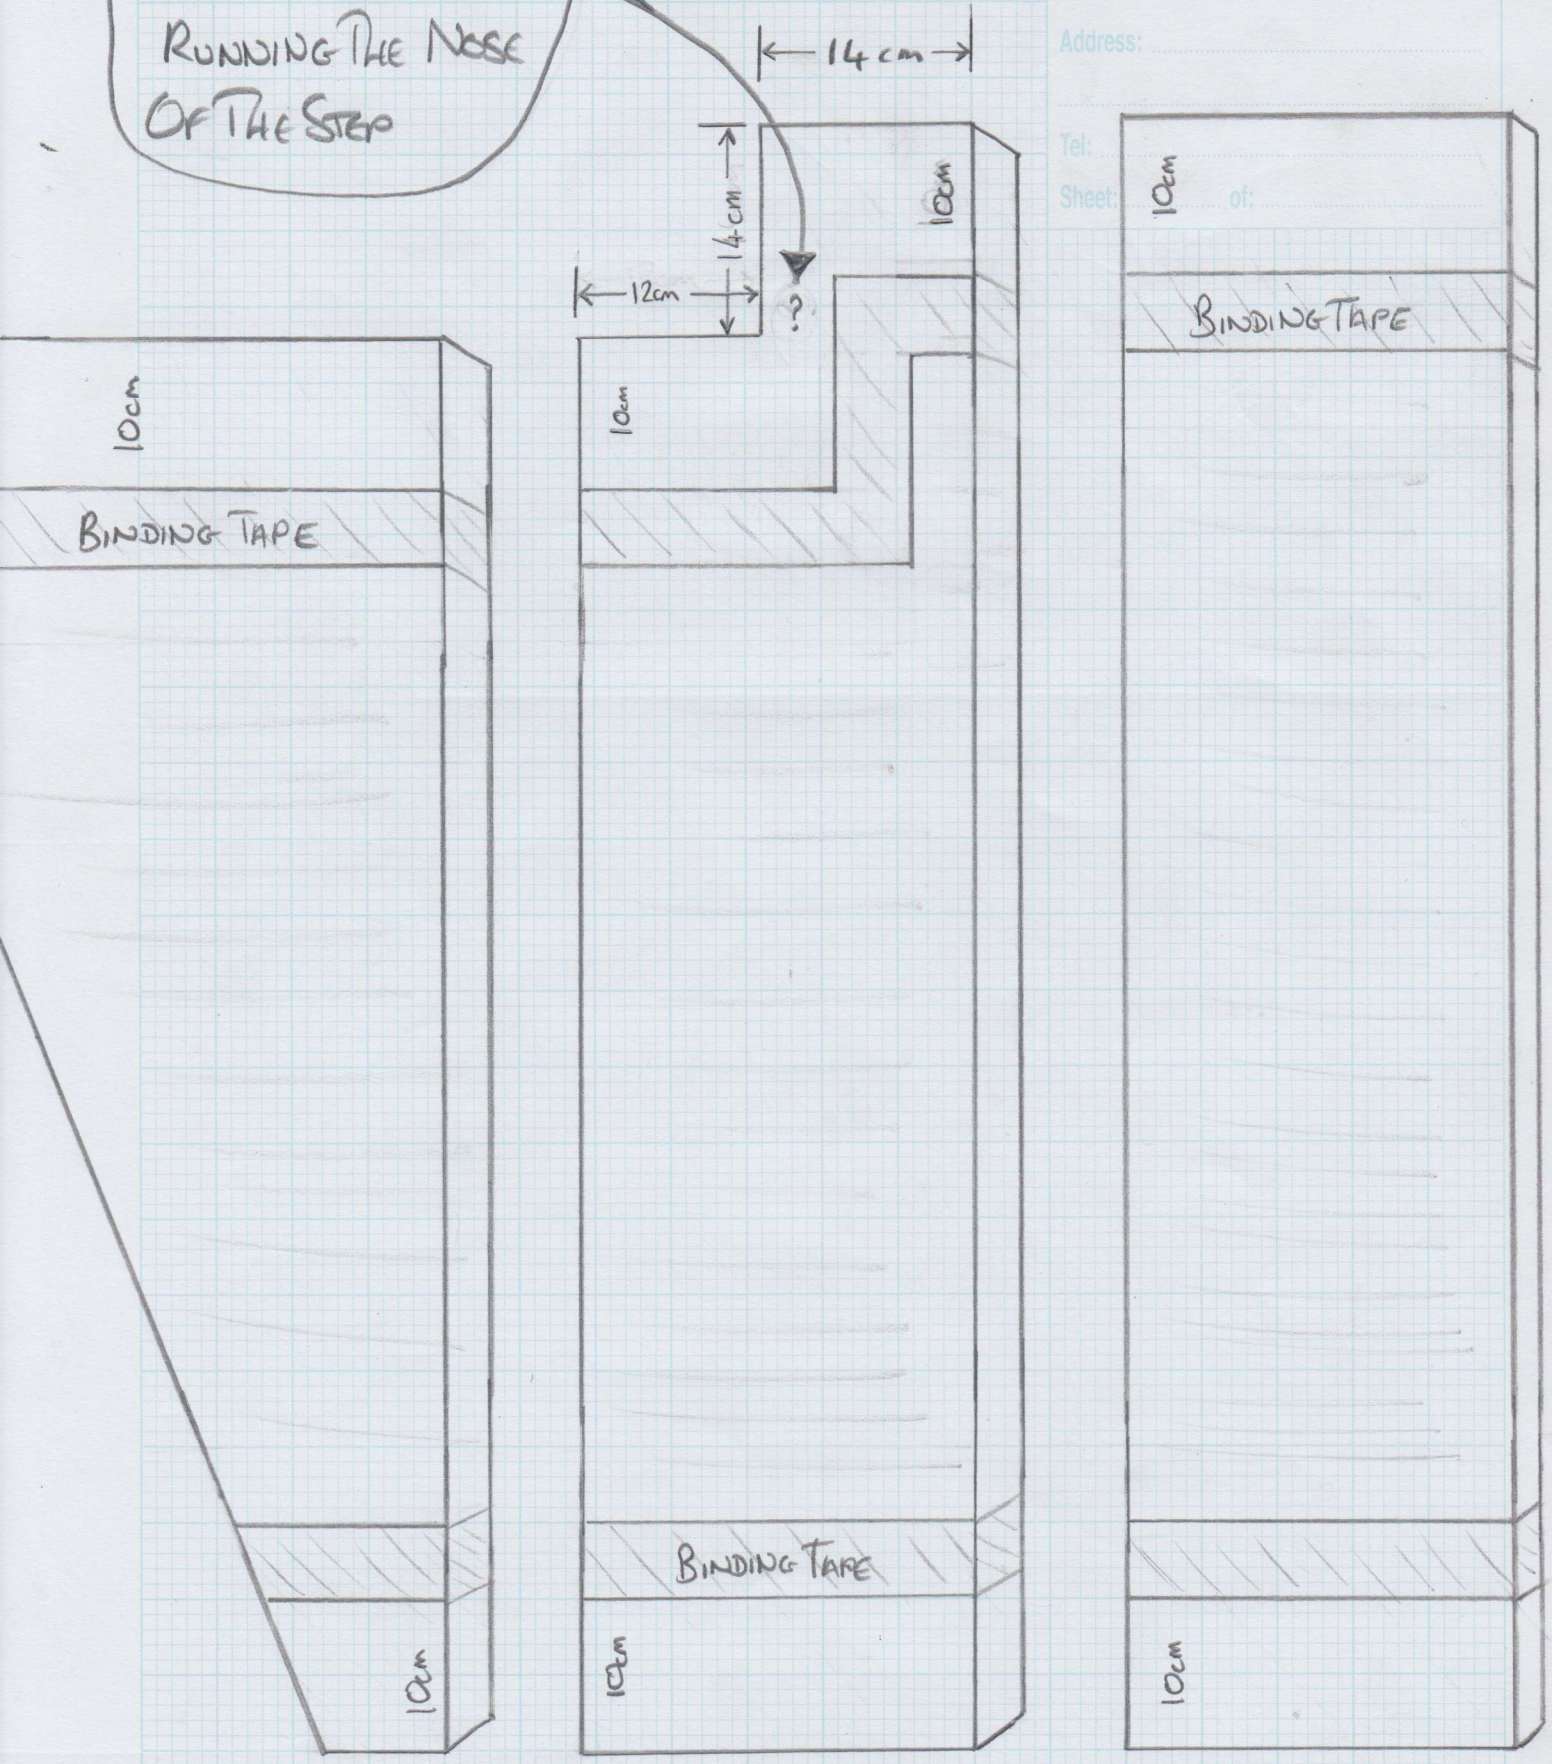
THIS GAP MUST BE SMALLER THAN OTHER PERIMETER GAPS TO AVOID THE BINDING TAPE OVER RUNNING THE NOSE OF THE STEP
