F/F FRONT & S&L.

Job No: F29144
Name: HUMBLE
Address: 57 CHALTON RD
SW6 7NH
Tel:
Sheet: 1 OF 5

FIRST FLOOR

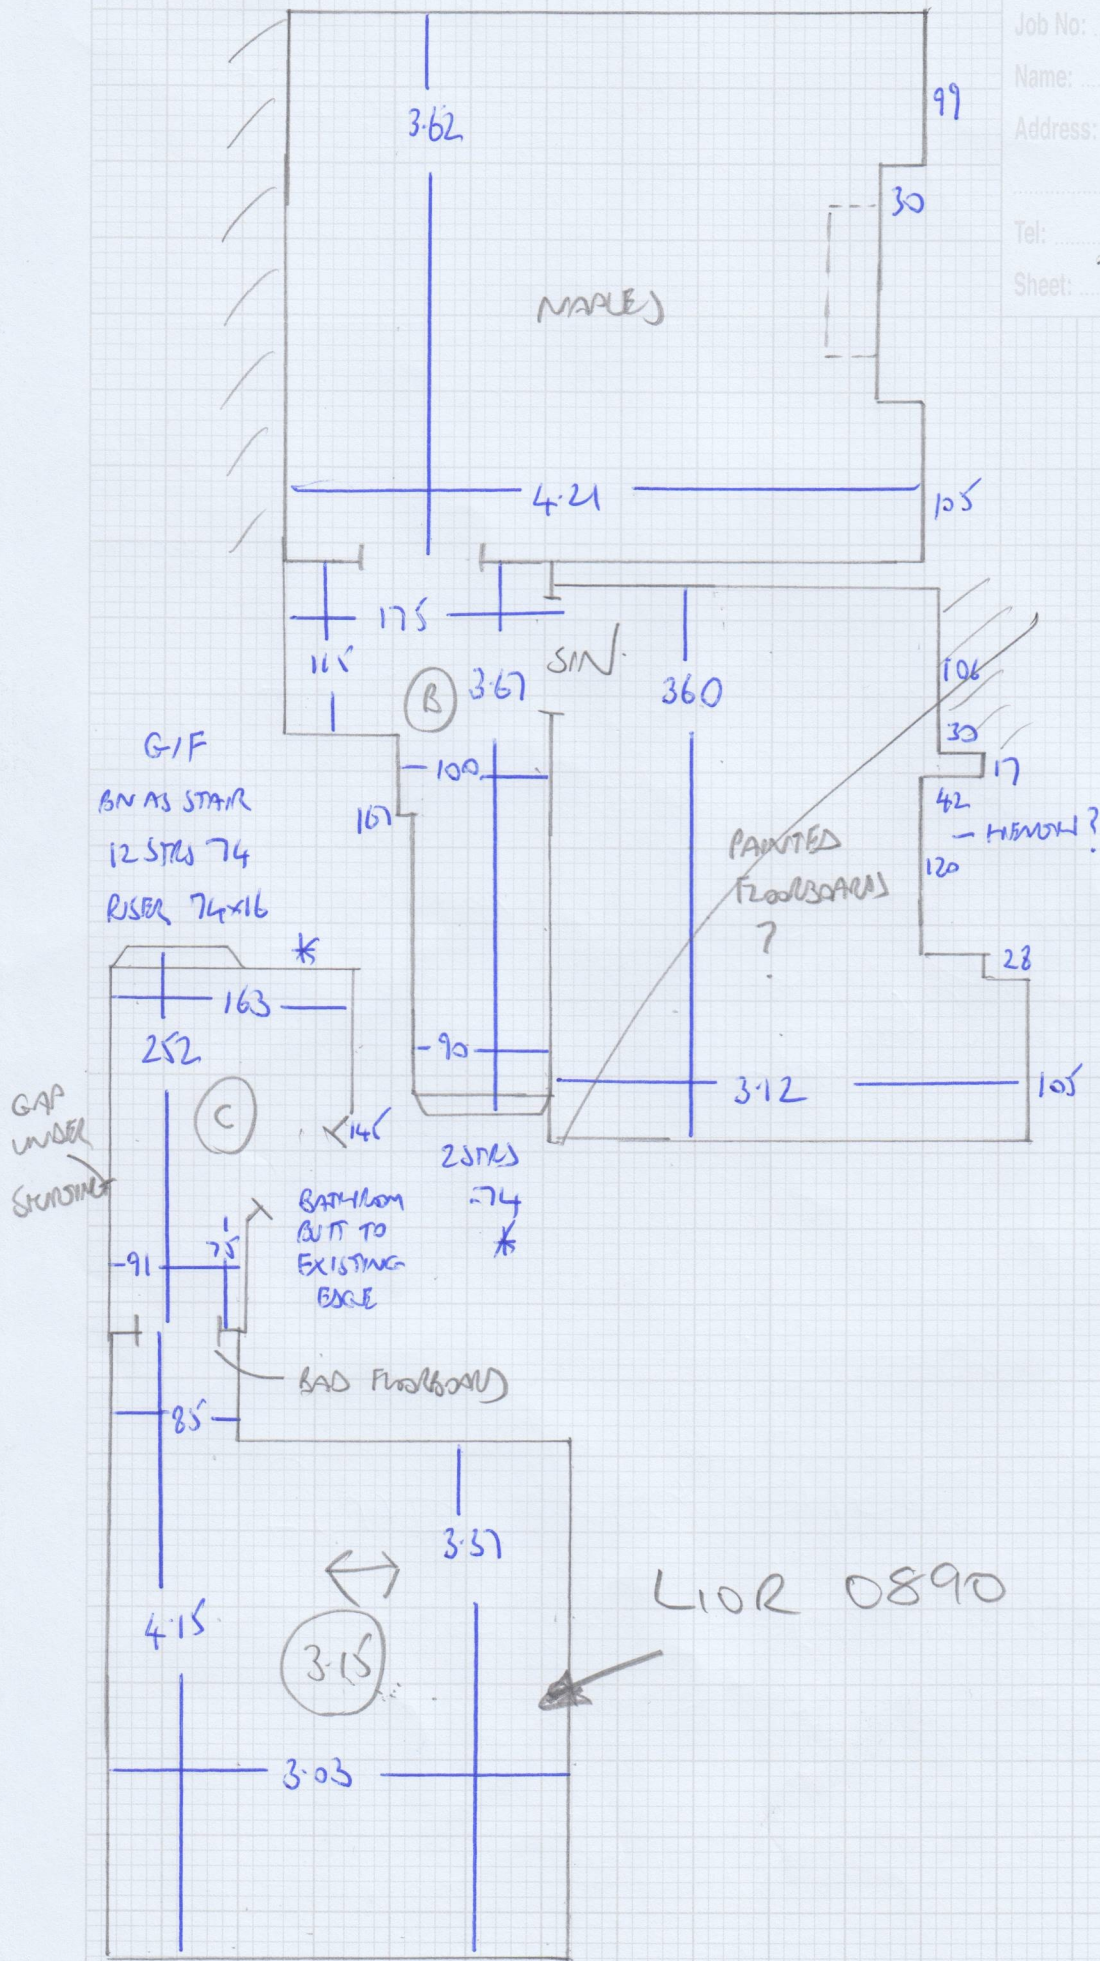
Job No: F29144
 Name: HUMBLE
 Address: 57 CHAMBERLAIN RD
 SW6 7NH
 Tel:
 Sheet: 2 of 5

G/F
 BN AS STAIR
 12 STEPS 74
 RISER 74x16

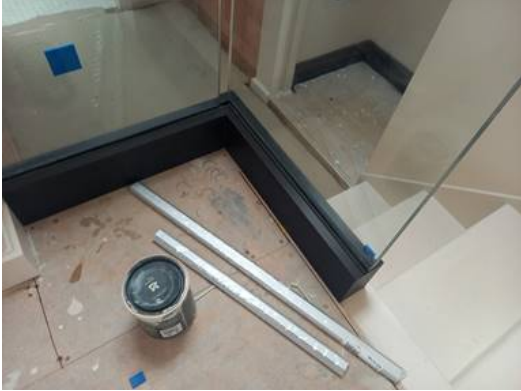
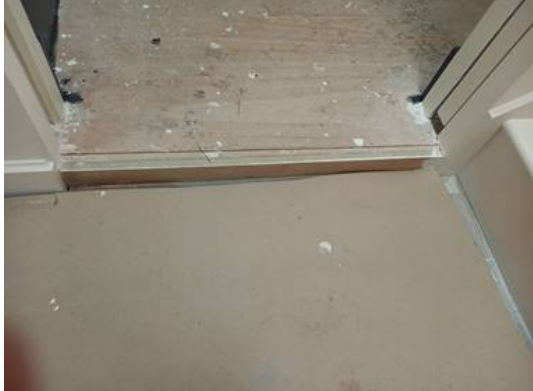
Glass panel in bedroom / finish from landing to parquet:

<p>Carpet will be fitted up against the base of the glass panel, as per normal skirting board. At the top of the step (end of glass panel) the carpet will be turned to finish, and at the top of the step can be fitted to finish under the edge of the landing (leaving the riser of the top step visible)</p> <p>Jamie/Martin – Call and speak to John, Pete or Paul if this is unclear</p>	<p>Carpet will run over the step/edge to finish against the parquet floor</p> <p>Jamie/Martin – Call and speak to John, Pete or Paul if this is unclear</p>

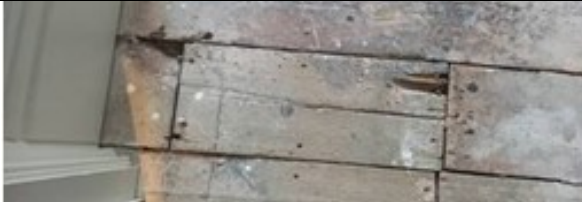
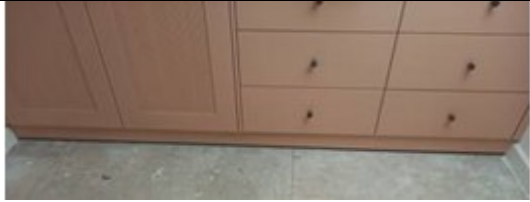
Areas that need attention prior to fitter's arrival:

<p>First floor rear bedroom: The floorboard inside the door has some chunks missing and ideally would be replaced prior to the carpet fitting.</p> <p>Customer response: We will fill this gap ahead of the fitting</p>	<p>Top Floor bedroom: The gap under the cupboard in the bedroom may not be fully covered by the carpet/underlay and may appear to be a dark shadow along the cupboard.</p> <p>Customer response: The gap here is 15mm - will this not be covered by the carpet build up?</p> <p>Jamie/Martin: Fit with gripper but DO NOT bolster down and let run in a bit to reduce any possible gap visibility</p>

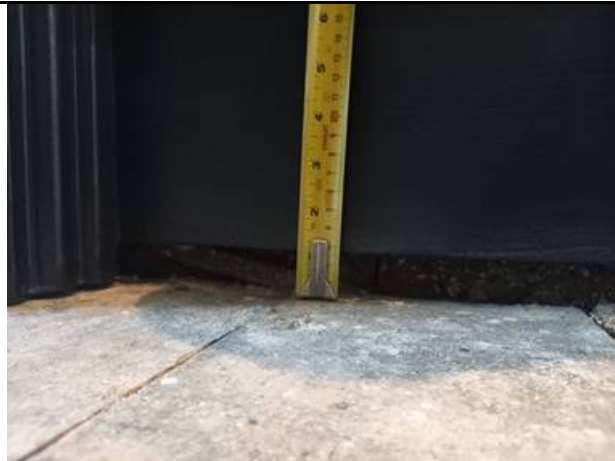
First Floor landing opposite the bathroom: There is a large gap that will not be fully covered by the carpet and will look like a dark shadow where higher than the carpet and underlay

Customer response: Customer will fill this gap ahead of the fitting

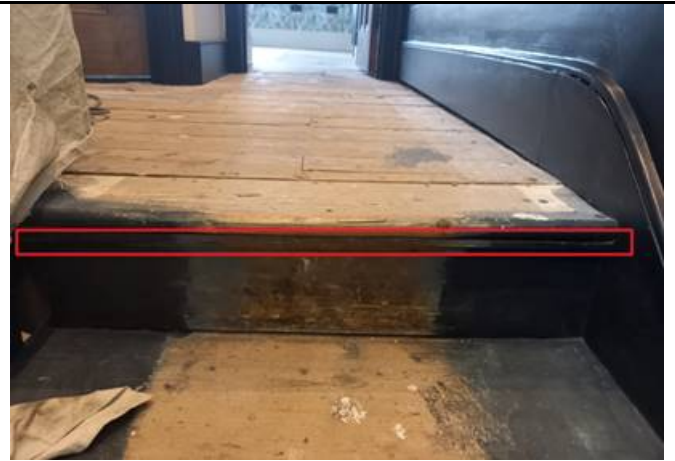
Edge of first floor landing/top of runner: The edge of the landing has a small quadrant that would not allow the runner on the riser to fix flat against the riser as you would like.

There are two options:

1: **Preferred:** You have the quadrant removed / step painted as required so that the riser is flat and runner can fit against it. This is so the runner starts under the edge of the landing as per our previous example picture.

2: Run the carpet full width over the step and have the runner start from the tread of the top step.

Customer response: Customer will remove the quadrant and paint prior to arrival
