R17512

Malden Manor  
Bowling Club  
Mans Park  
New Malden  
ICTJ 6AU

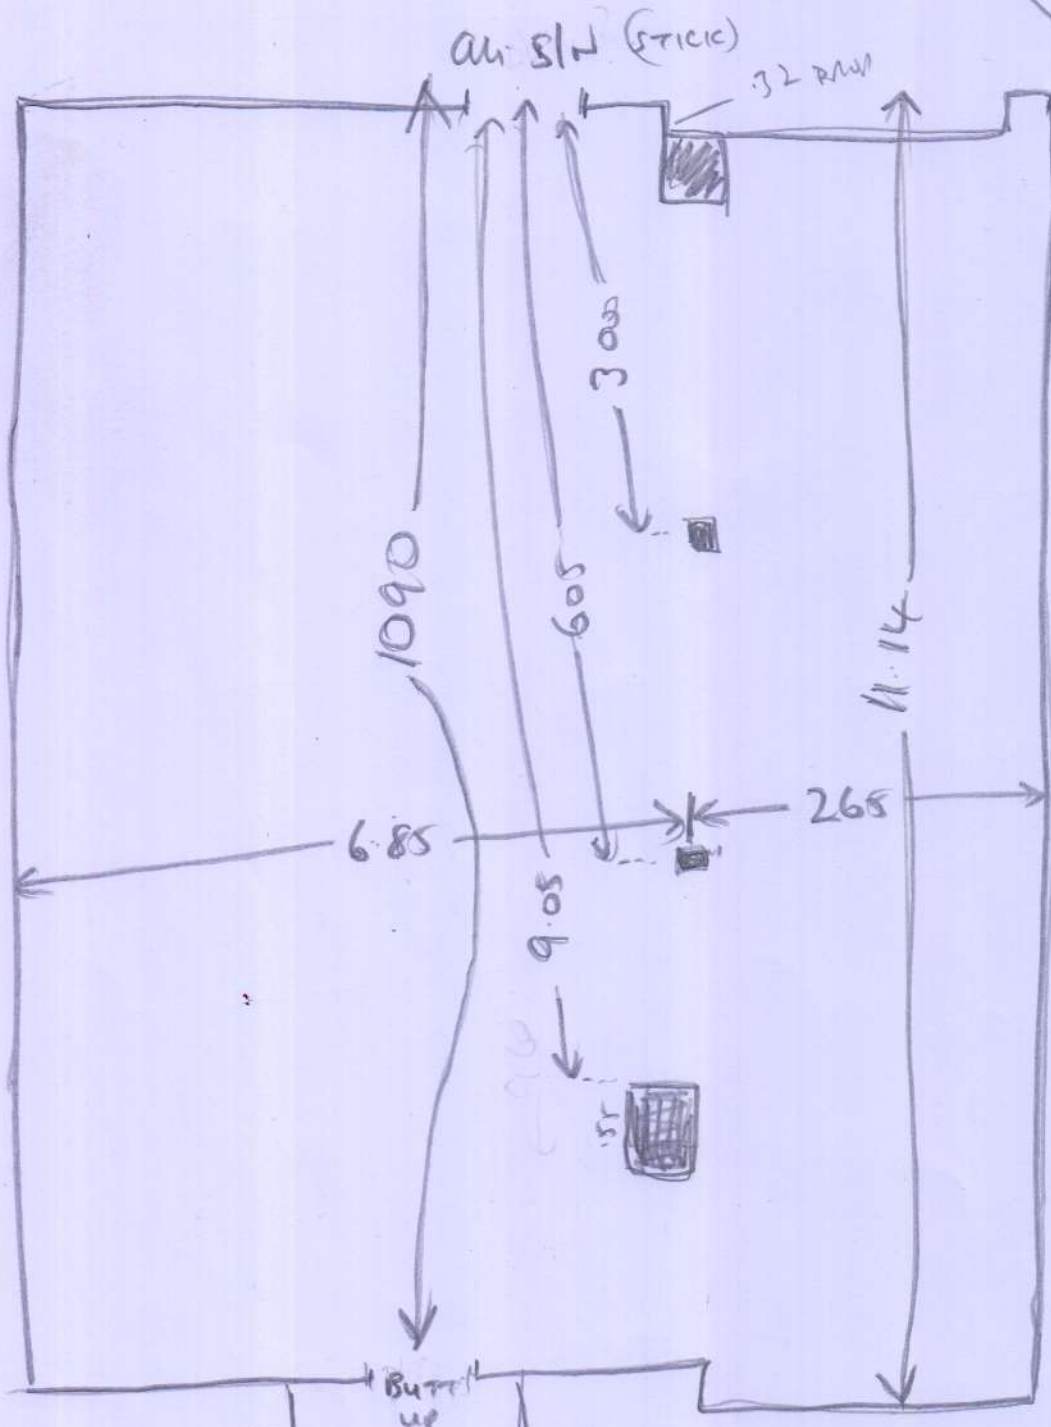
Loc 1

EXISTING SUB  
FLOOR SCREEN IS  
CALCIUM SULPHATE  
ANHYDRATE

This area, but customers own  
tiles + butt up to main tiles

Needs P12 prime  
u Slap 1100

1 P4 Tackifier

Put back  
own tiles
