Amtico

Site Investigation Report

Background

Approx. 66m² Amtico Spacia Sun Bleached Oak XL planks fitted into a kitchen diner, hall and utility room using HTE adhesive 09/04/18. Ms Ratcliffe has reported that some very small gaps have appeared by the patio doors.

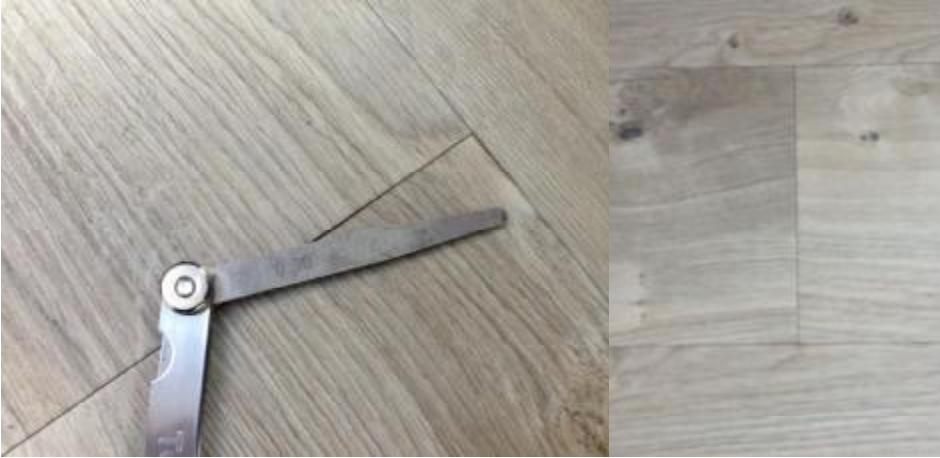
The gaps were measured and found to be 0.3mm.

In my opinion the Amtico planks and adhesive supplied are of standard quality and are not at fault in any respect. It is virtually impossible to install a tiled floor with no gaps between the tiles. The Contract Flooring Association guidelines state that no gap in the body of the floor should exceed 0.3mm and even gaps greater than this are unlikely to detract from the overall performance or the aesthetics of the floor. The gaps were effectively closed up using the back of a steel knife. No further action from Amtico.

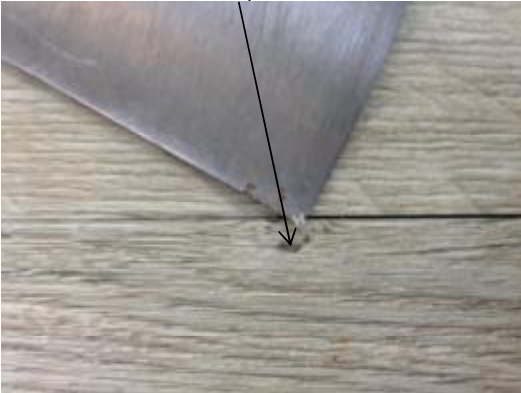
There was also some dirt present in between the bevelled edges which can create the illusion of a larger gap.
