S29338

Friday, 12 January 2018

Prepared For Mehta

6 Issues Identified

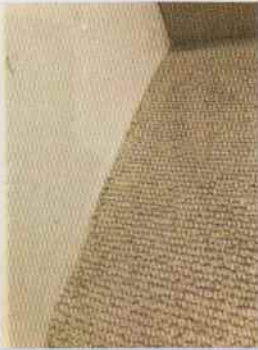
Issue 1

Stairs like this need to be bolstered to tuck the carpet neatly against the skirting

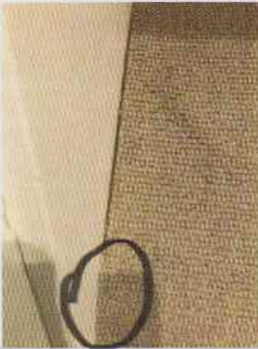
Issue 2

Because the bit against the wall is one rib too wide, it is causing the edge of the stair carpet to pucker up. Can this be improved.

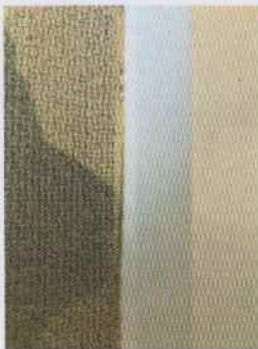
Issue 3

Customer is going to fix the facing of the cupboard here. The pressure from the bolster has pushed it back and the carpet has lifted off the gripper because of this. Please restretch back onto the gripper

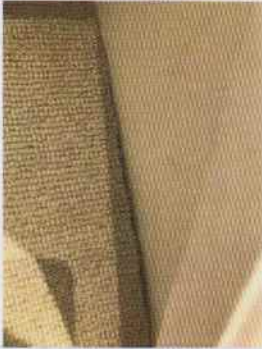
Issue 4

In several areas in the property, the carpet needs restretching onto the gripper as it appears short in places. Please run through whole job
